# Manhole Inspection Summary

Manhole # S55C\_\_002MH

Insp Date: **6/23/08 9:40 AM**

**Location** Address: **rear 3417 e fayette st**

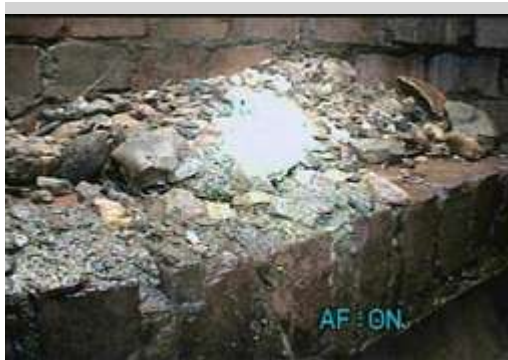
Defect 3

Condition: ☐ Sound ☐ Cracked ☐ Root Intrusion ☐ Deteriorated ☐ Leaks ☒ **Debris**

bench debris

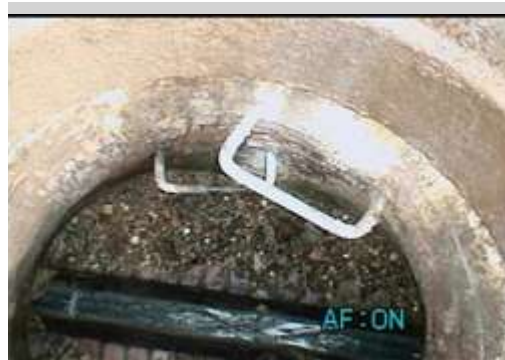
Defect 2

**Steps** Count: **2** Missing: **0** ☒ **Corroded**

steps

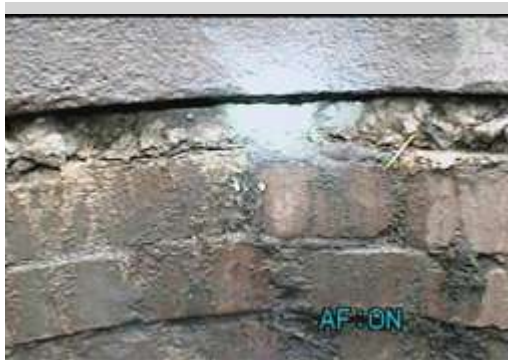
Defect 1

**Frame** Offset: **0** (in.) Condition: ☐ Sound ☐ Cracked ☒ **Leaks**

Condition: ☐ Sound ☐ Cracked ☐ Root Intrusion ☒ **Loose Brick** ☒ **Deteriorated**

chimney loose bricks,  
cracked,deteriorated,  
frame leaks, frame adj

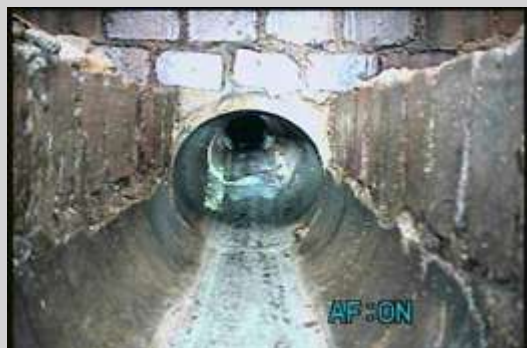
12 O'Clock Outflow

8 in. Circular Gravity Sewer  
Pipe Out @ 12 O'Clock

Pipe Material: **Clay** ☐ Pipe Lined

Invert Depth: 6.01 (ft.) Flow Characteristics: **Slow**

Infiltration: **None** Pipe Seal Cond: **Unknown**

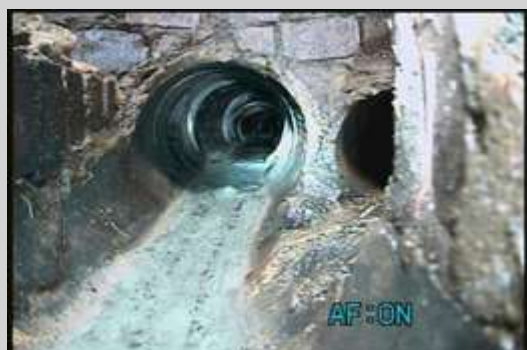
6 O'Clock Inflow

8 in. Circular Gravity Sewer  
Pipe In @ 6 O'Clock

Pipe Material: **Clay** ☐ Pipe Lined

Invert Depth: 5.90 (ft.) Flow Characteristics: **Slow**

Infiltration: **None** Pipe Seal Cond: **Unknown**

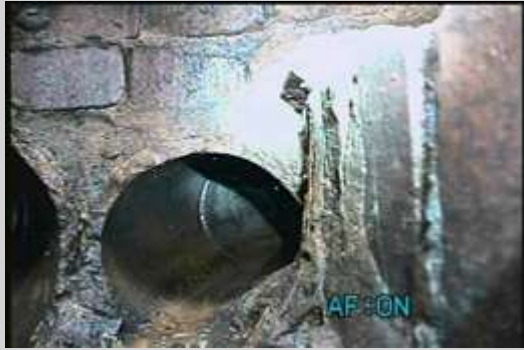
7 O'Clock Inflow

8 in. Circular Gravity Sewer  
Pipe In @ 7 O'Clock

Pipe Material: **Clay** ☐ Pipe Lined

Invert Depth: **5.92** (ft.) Flow Characteristics: **Slow**

Infiltration: **None**

Connects To: **House connection / Service line**
